CITY OF BATTLE CREEK

Historic District Commission Meeting
(10 N. Division St., City Commission Chambers, Ste. #301 on 3rd Floor)

Monday, March 9, 2020 at 4:00

Staff Report

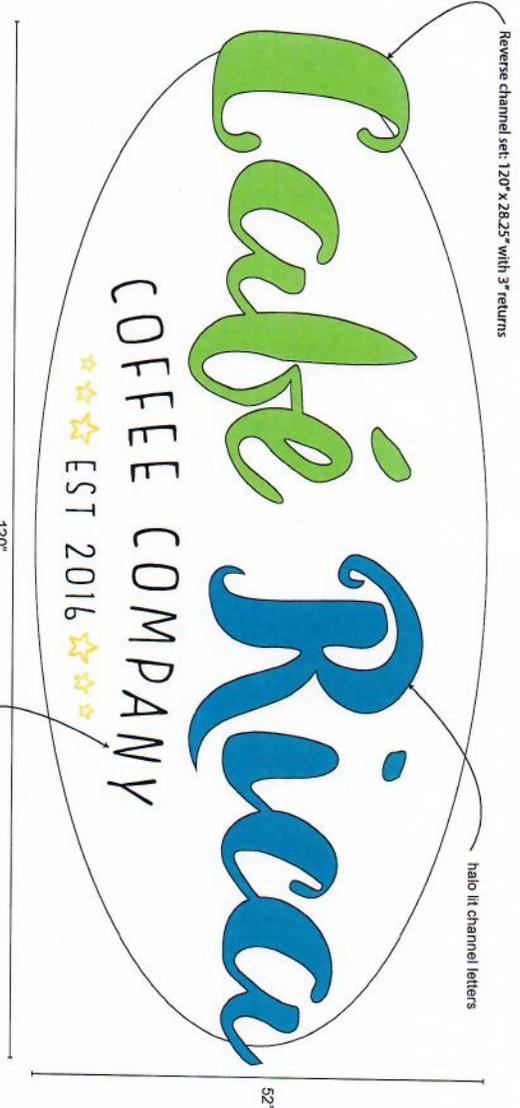
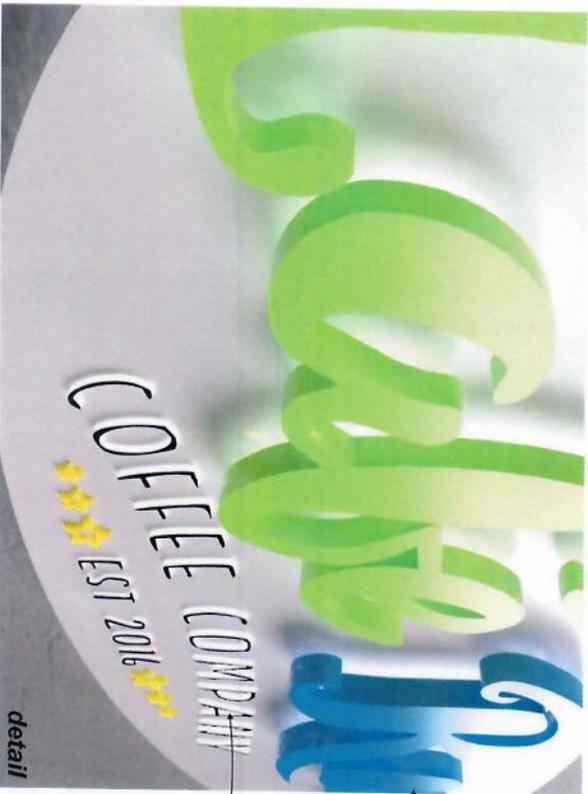
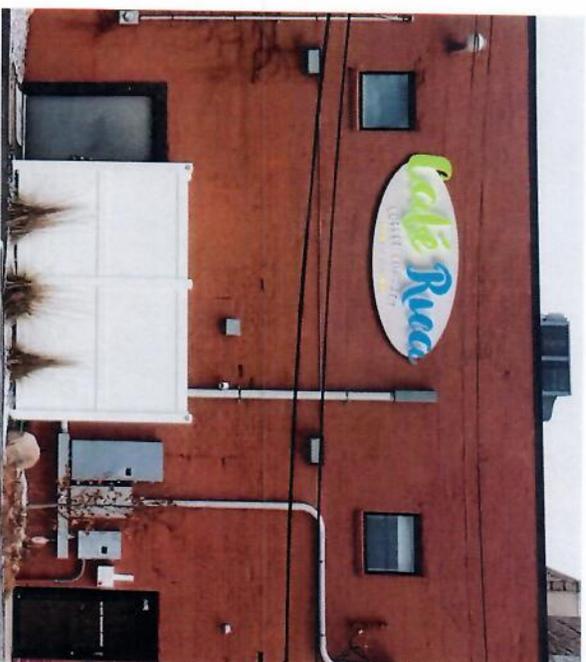
Mounting:
Secured to brick wall with recommended fasteners.

- Matte White
- Satin Green - Pantone XXXC
- Satin Blue - Pantone XXXC
- Oracal 8900-021 Yellow
- Oracal 8900-070 Black

As noted earlier, the proposed signs will be mounted to the back brick elevation, and therefore, result no alteration of the rest of the building, structure, or property.

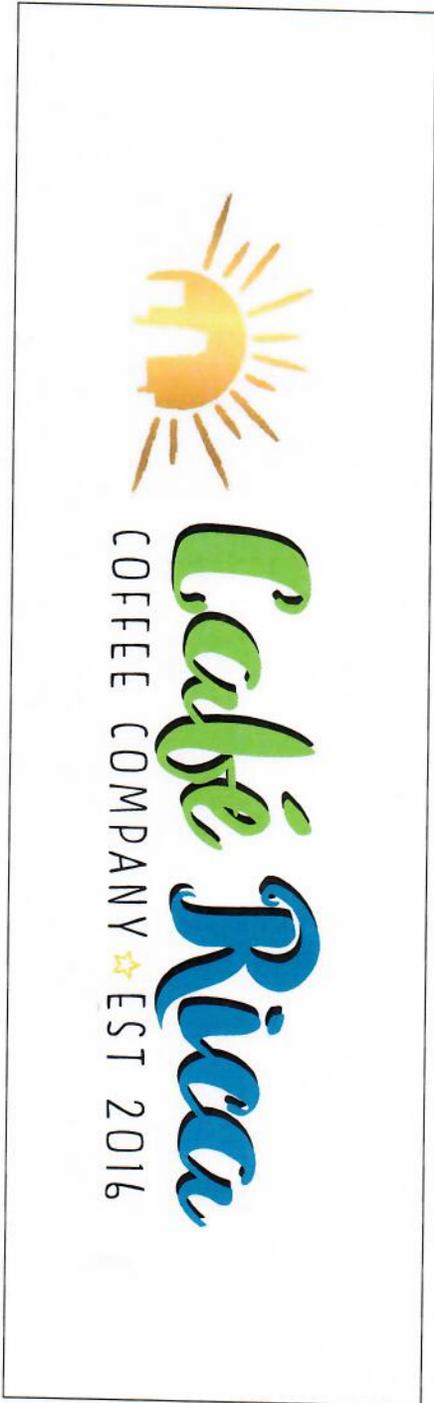
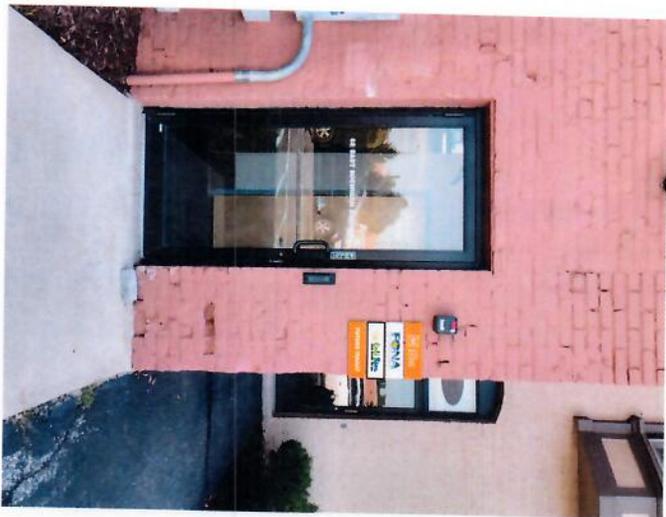
Direct mount to brick wall
with recommended adhesive

- Matte White
- Satin Green - Pantone XXXC
- Satin Blue - Pantone XXXC
- Oracal 8800-021 Yellow
- Oracal 8800-070 Black

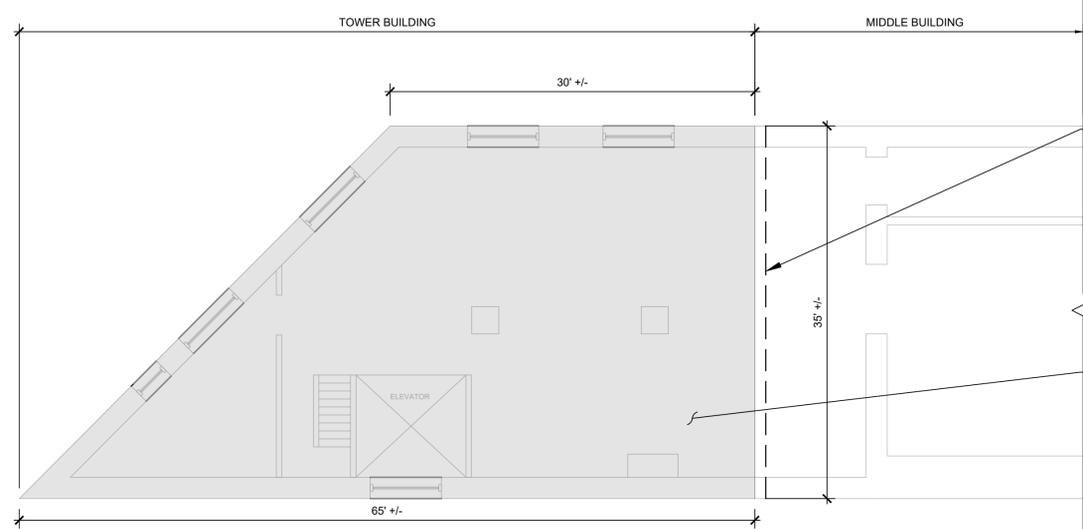
3 THIRD FLOOR DEMOLITION PLAN
N.T.S.

INSTALL TEMPORARY SHORING OF STRUCTURAL FRAMING AT SOUTHWEST EDGE OF MIDDLE BUILDING. PLAN FOR EVENTUAL STRUCTURAL INFILL OF WALLS FOR CLOSURE OF BUILDING. FOLLOWING SHORING AND TOWER DEMOLITION, CONTACT ENGINEER FOR FURTHER INSPECTION. DO NOT INFILL WALLS PRIOR TO ENGINEER INSPECTION AND DESIGN. SOME CONTENT REMOVAL WILL BE REQUIRED TO ACCESS THE AREA FOR SHORING.

STARTING AT THE ROOF LEVEL, CAREFULLY REMOVE ALL MATERIALS (WALLS, STRUCTURAL BEAMS AND COLUMNS, FLOOR, STORED CONTENTS) IN TOWER AREA.

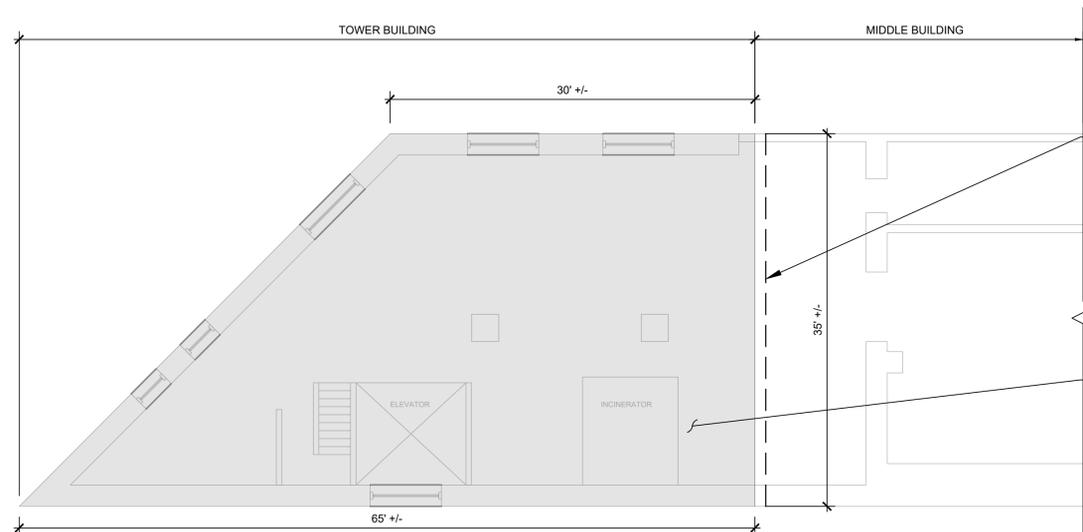
2 SECOND FLOOR DEMOLITION PLAN
N.T.S.

INSTALL TEMPORARY SHORING OF STRUCTURAL FRAMING AT SOUTHWEST EDGE OF MIDDLE BUILDING. PLAN FOR EVENTUAL STRUCTURAL INFILL OF WALLS FOR CLOSURE OF BUILDING. FOLLOWING SHORING AND TOWER DEMOLITION, CONTACT ENGINEER FOR FURTHER INSPECTION. DO NOT INFILL WALLS PRIOR TO ENGINEER INSPECTION AND DESIGN. SOME CONTENT REMOVAL WILL BE REQUIRED TO ACCESS THE AREA FOR SHORING.

STARTING AT THE ROOF LEVEL, CAREFULLY REMOVE ALL MATERIALS (WALLS, STRUCTURAL BEAMS AND COLUMNS, FLOOR, STORED CONTENTS) IN TOWER AREA.

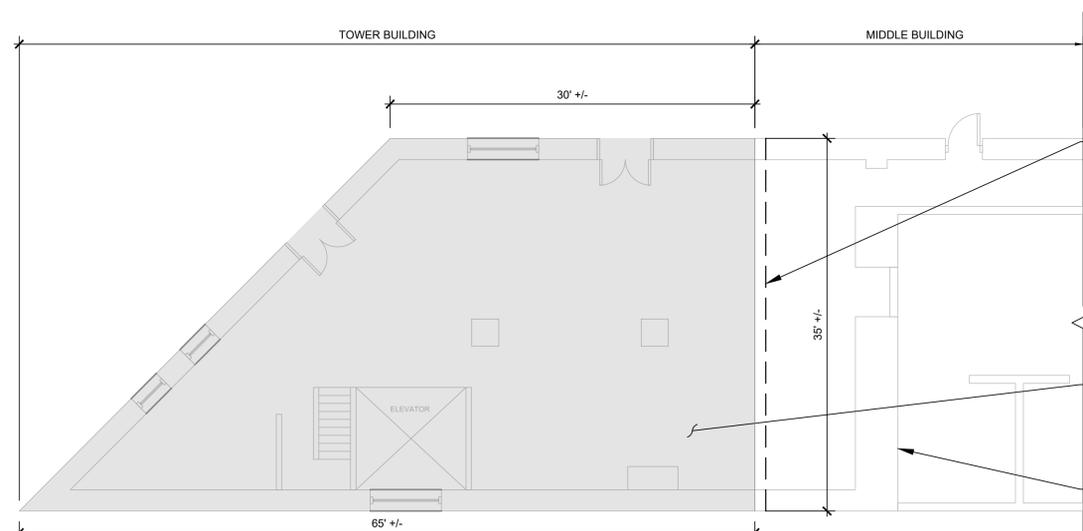
INSTALL TEMPORARY SHORING OF STRUCTURAL FRAMING AT SOUTHWEST EDGE OF MIDDLE BUILDING. PLAN FOR EVENTUAL STRUCTURAL INFILL OF WALLS FOR CLOSURE OF BUILDING. FOLLOWING SHORING AND TOWER DEMOLITION, CONTACT ENGINEER FOR FURTHER INSPECTION. DO NOT INFILL WALLS PRIOR TO ENGINEER INSPECTION AND DESIGN. SOME CONTENT REMOVAL WILL BE REQUIRED TO ACCESS THE AREA FOR SHORING.

STARTING AT THE ROOF LEVEL, CAREFULLY REMOVE ALL MATERIALS (WALLS, STRUCTURAL BEAMS AND COLUMNS, FLOOR, STORED CONTENTS) IN TOWER AREA.

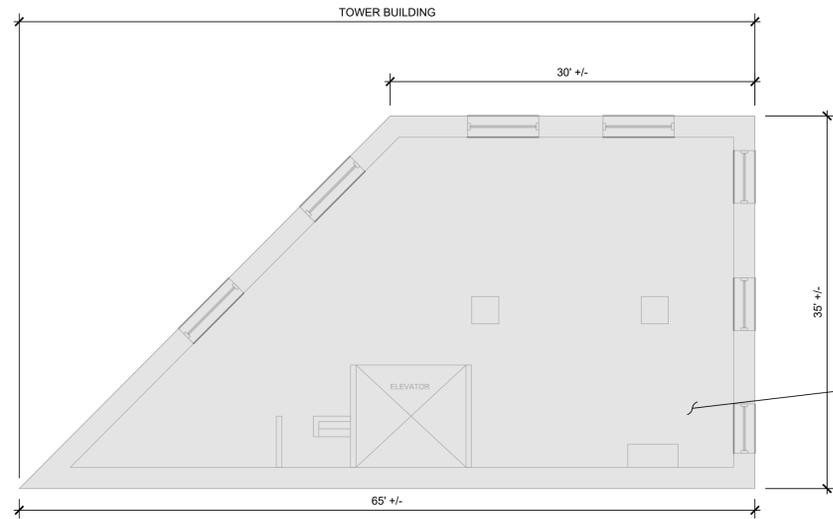
3 SIXTH FLOOR DEMOLITION PLAN
N.T.S.

STARTING AT THE ROOF LEVEL, CAREFULLY REMOVE ALL MATERIALS (WALLS, STRUCTURAL BEAMS AND COLUMNS, FLOOR, STORED CONTENTS) IN TOWER AREA.

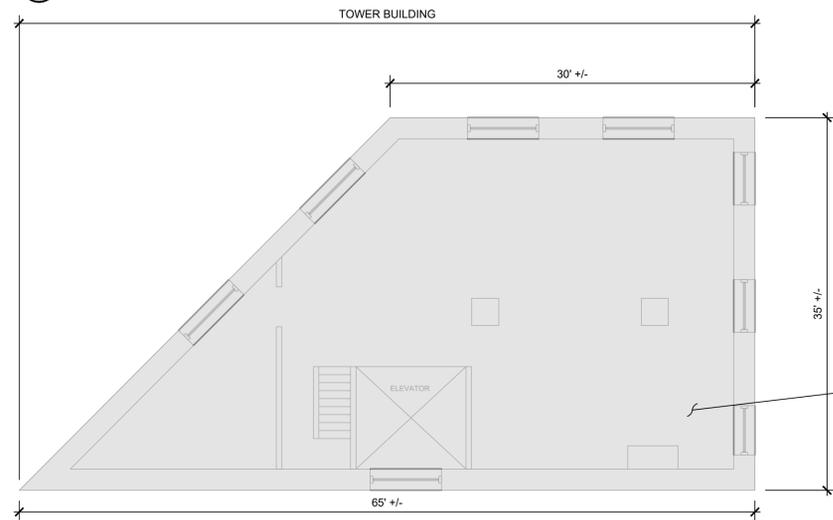
2 FIFTH FLOOR DEMOLITION PLAN
N.T.S.

STARTING AT THE ROOF LEVEL, CAREFULLY REMOVE ALL MATERIALS (WALLS, STRUCTURAL BEAMS AND COLUMNS, FLOOR, STORED CONTENTS) IN TOWER AREA.

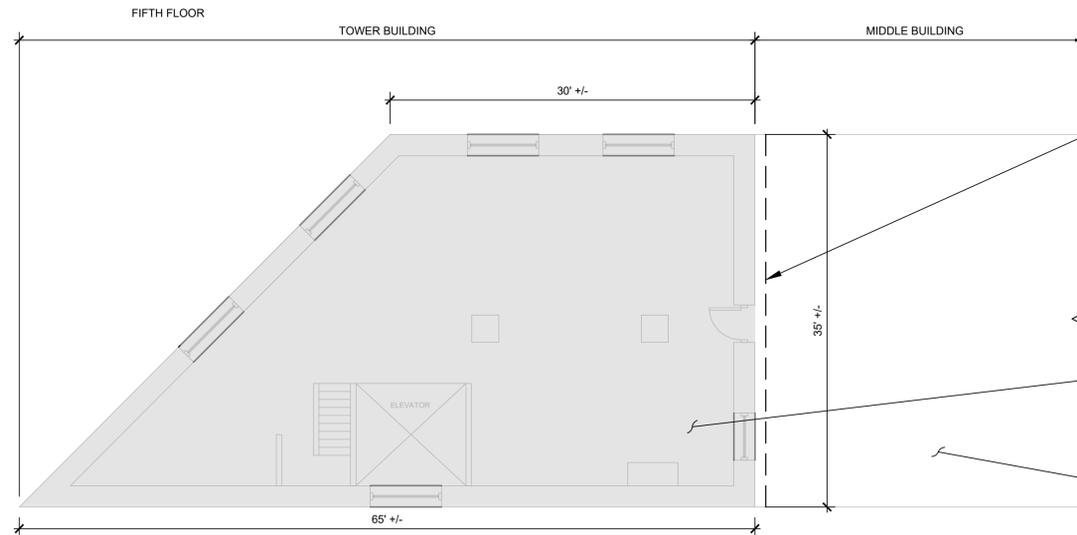
INSTALL TEMPORARY SHORING BELOW OF STRUCTURAL FRAMING AT SOUTHWEST EDGE OF MIDDLE BUILDING. PLAN FOR EVENTUAL STRUCTURAL INFILL OF WALLS FOR CLOSURE OF BUILDING. FOLLOWING SHORING AND TOWER DEMOLITION, CONTACT ENGINEER FOR FURTHER INSPECTION. DO NOT INFILL WALLS PRIOR TO ENGINEER INSPECTION AND DESIGN. SOME CONTENT REMOVAL WILL BE REQUIRED TO ACCESS THE AREA FOR SHORING.

STARTING AT THE ROOF LEVEL, CAREFULLY REMOVE ALL MATERIALS (WALLS, STRUCTURAL BEAMS AND COLUMNS, FLOOR, STORED CONTENTS) IN TOWER AREA.

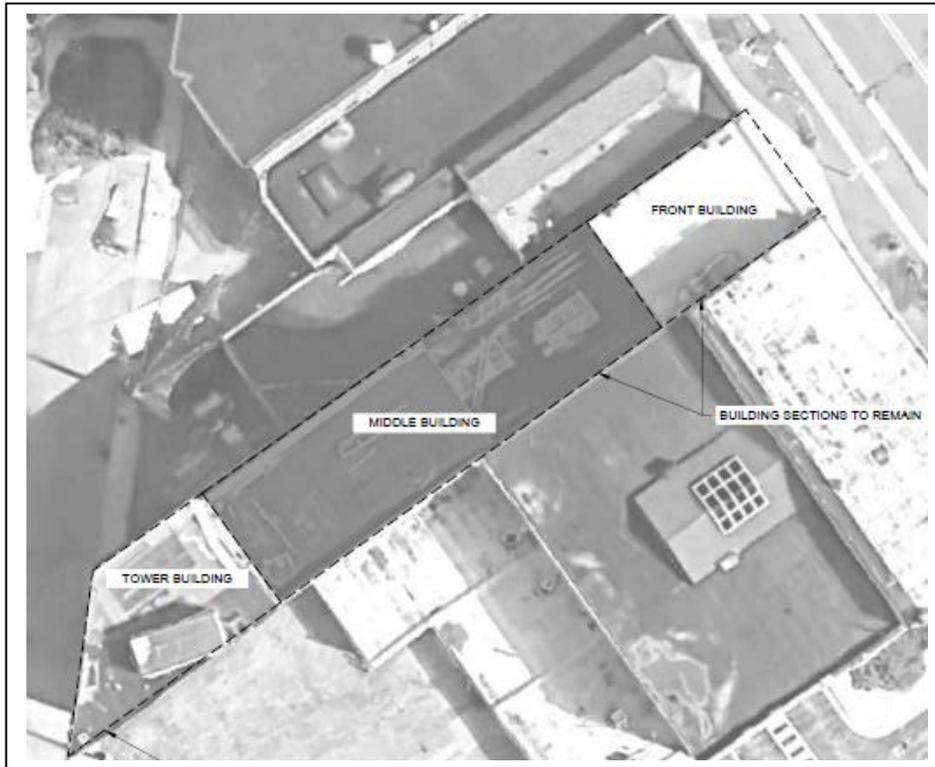
Figure 3. Shows sections of the building: front, middle, and tower (rear).

The subject building is known as the Binder Building, and is located at 34 E. Michigan Avenue in the local historic Central Business District (CBD). See Figures 1 & 2. This building consists of three sections: front section facing E. Michigan Avenue, middle section, and rear section facing Monroe Street South. According to the City's Assessor's data, the building was built in 1887. A slaughterhouse business occupied the building in its early years, followed by various restaurants. However, the building has been unoccupied during the past 20 years. It is currently used as general storage by the owner. The contents and value of which are unknown to staff. This building is quite long as it stretches from E. Michigan Avenue to S. Monroe Street. The building abuts other buildings along E. Michigan Avenue, and is surrounded by parking lots at the rear. The building varies in height, with three stories along E. Michigan Avenue (front) and six stories along S. Monroe Street (rear). The rear portion is known as the tower and is shaped as tall flat iron, making it one of the more unique buildings in the area.

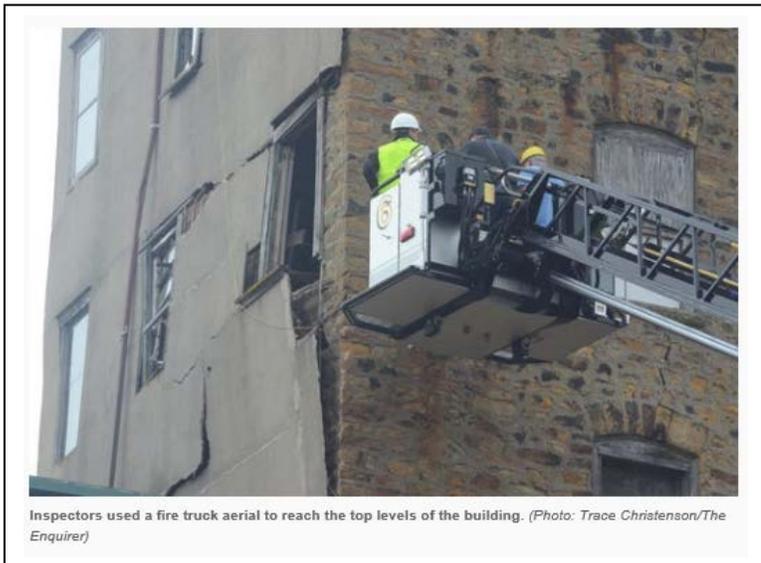
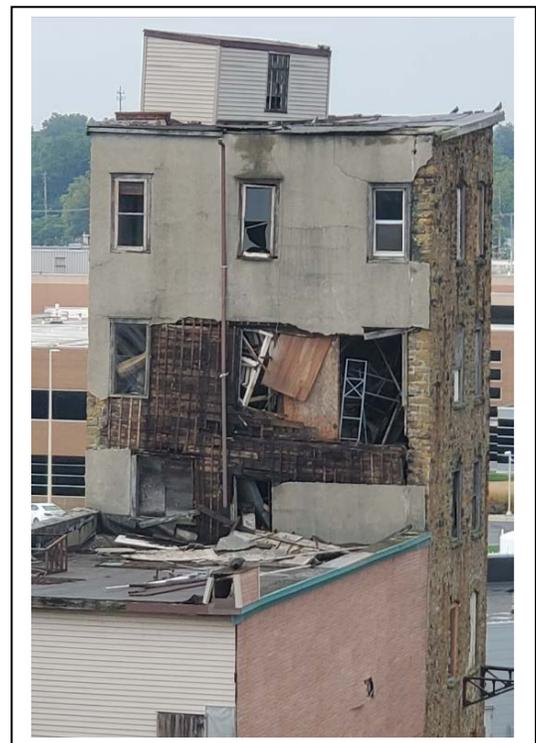
Figures 4 & 5. (Left) Photograph showing the use of a lift truck in September to safely view various building conditions. Picture provided by Trace Christenson obtained from the Battle Creek Enquirer. (Right) Picture taken September 16, 2019 showing the buckling of the outer material of the back elevation near S. Monroe Street.

floor which now places additional pressure on lower floors and weight load. The roof lost more structural support with the collapsed 3rd floor. Large openings in the building are allowing more weather elements inside the building. The north wall is compromised and partially collapsed onto a lower roof section. Portions of adjacent buildings and parking areas were still unusable due to possible building collapse. In its current condition, Mr. Wilkinson recommended affirming the property as a Dangerous Building. “Mr. DeBolt states that his intent is to repair the building as best he can due to its historical nature, and would like the city to assist him an (and) saving it.” Mr. Bolek and Mr. Wilkinson expressed their concerns about the severe condition of the building, the stability needed for any repairs, and requiring engineered plans for any repairs and stabilization. Mr. DeBolt indicated that he would like to start work soon. The hearing concluded with the property deemed a Dangerous Building, and that Mr. DeBolt had 30 days to bring the building into compliance (with the International Property Maintenance Code 2015). The Dangerous Buildings Hearing minutes are attached. Thirty days concluded on November 20, 2019. As of the date of the subject memorandum, compliance has not been obtained.
